Rehabilitation Methods of Rasuna Said House in Agam Regency, West Sumatra

Riki Adriadi¹, I Nengah Tela², Jonny Wongso³

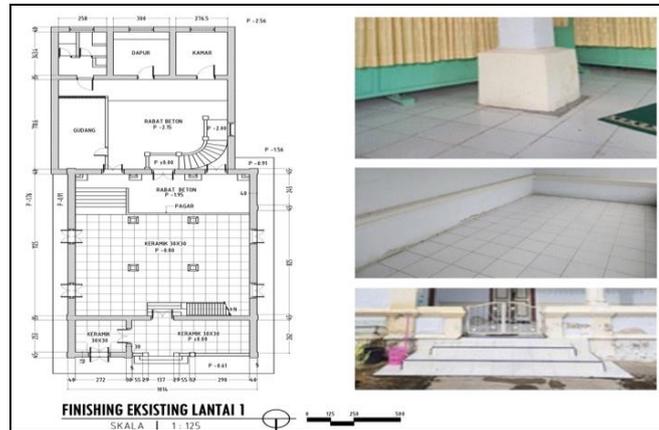
Floor Rehabilitation Methods. The first floor of the house will be returned to its original position, namely the stage-shaped floor is under the floor. For the first floor, the material will also be returned by reinstalling the wooden floor. Because the current condition of the floor is to use a ceramic floor that has been changed from the shape and material of the floor when the building was first built. To restore the condition of the floor

Figure 1. Existing condition of the 1st floor.

to its original shape, it is done by raising the middle floor so that it is parallel to the floor at the front. The position of the floor beams is right above the rectangular foundation that protrudes above the tiled floor now. Installation of wooden floors by not dismantling the existing ceramic floors. The floor framework uses wood with good quality, no defects and selected wood in a completely dry condition. Before installing all wooden frames must be sprayed against termites. The condition of the floor is now as shown in Figure 1.

The method of working on the 1st floor, namely the wooden floor framework is installed on an existing foundation with a height of 80 cm from the current floor surface or the floor level is parallel to the surface of the front porch floor. The floor framework uses wooden beams with a size of 8 x 15 cm, mounted on the foundation on the column and the foundation on the wall mounted transversely from the floor plan position. Furthermore, the wooden beam frame above the transverse beam is installed with a transverse beam measuring 6 x 15 cm with a distance of 60 cm between one beam and another. The detailed drawing of the wooden floor installation is shown in Figure 2.

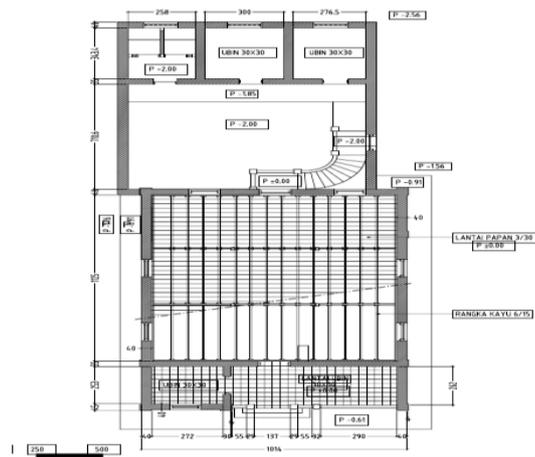
Figure 2. Details of wood floor installation

Furthermore, on the beam measuring 6 x 15 cm, a floor plank with a size of 3 x 30 cm is installed as a floor covering. The boards are installed parallel to the neat, tight, no gaps between one board with another board. So that the installation is neat and there are no gaps or cavities, the board is formed with a groove and tongue system, as shown in Figure

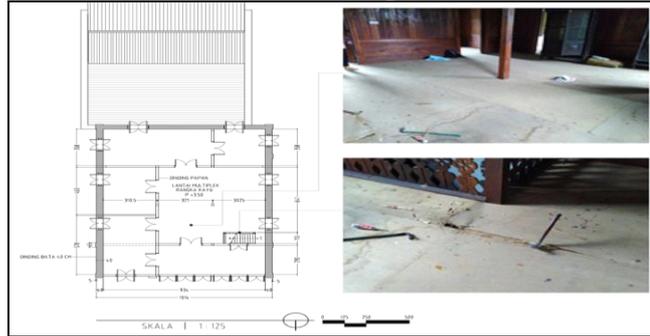
The method of working on the second floor, to restore the floor material to its original condition, is to use boards, as in Figure 4.5, the floor that currently uses plywood will be demolished. The demolition must be carried out very carefully so that the wooden floor frame is not damaged. After the plywood floor has been dismantled, a careful inspection of the floor framework is carried out to determine if there is any damage to the wooden frame. If it is found that there is a damaged wooden frame such as being eaten by termites, repairs will be carried out, both minor repairs and moderate repairs.

Figure 3. 2nd floor using plywood finishing

The method of carrying out the work on the wooden floor on the second floor is the same as the installation on the first floor, because on the second floor, a frame made of wood is used. The replacement of the wooden frame is carried out on damaged wood, while the plywood as a floor covering is replaced by all, by dismantling all the installed plywood. After all the plywood is dismantled, then check all the wooden frames carefully. If a damaged wooden frame is found, whether lightly damaged, moderately damaged, or heavily damaged, it must be repaired first before the floor covering is installed.

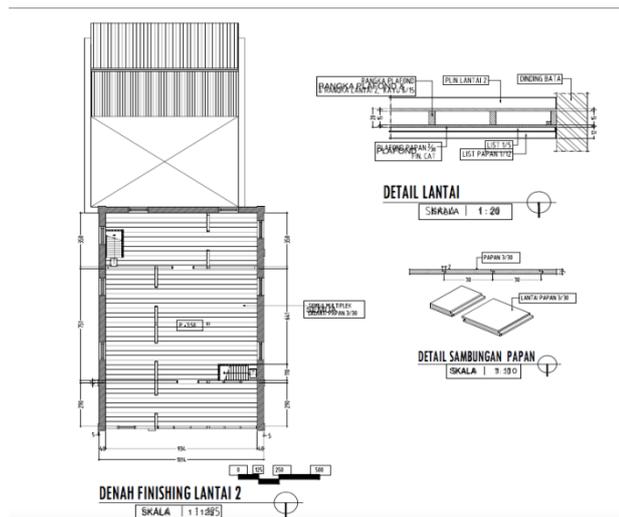
Figure 4. Second Floor Rehabilitation Plan

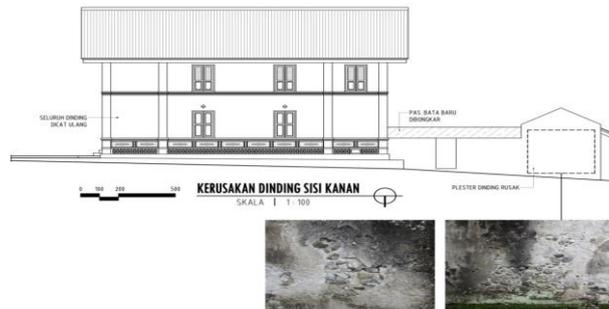
plaster is porous and the paint is peeling off. For porous walls, repairs must be made using the same material. How to repair a porous wall, first stripping the layer of porous brick walls until the masonry is visible. After stripping, the wall is ready to be plastered using a mixture of cement, sand and water. A mixture of cement and sand with a ratio of 1 to 4, namely 1 cement and 4 sand or following the requirements specified in the concrete standard.

Figure 5. Damage to brick walls

In carrying out the rehabilitation of the brick wall, the first work to be done is the work of stripping the layer of porous walls or plaster. After all layers of porous walls are opened, plastering materials are prepared, plastering materials, namely good quality sand, cement and clean water so that the cement and sand mixture binds perfectly. The working tools for plastering are; A hoe is used to make stucco mortar, a mortar / mortar spoon is used to attach the stucco mortar to a brick wall, a bucket is used to measure the mortar and is used to take water and to carry the stucco mortar, thread is used as a tool for workers to guide workers so that the plaster wall is flat and smooth. perpendicular, nails are used as thread hooks and a reference after the measurement is complete, hammer is used to drive nails, lot is used as a tool to ensure flatness or perpendicularity, water tanks are used to collect water for plastering needs, sand sieve is used to cover sand from dirt and stones, ondrong a tool that functions to flatten the stucco mixture when it is attached to a brick wall, pauser a tool that functions to flatten the stucco mixture that has been affixed using a mortar or mortar spoon, this tool is usually made of long rectangular wood, or of aluminum.

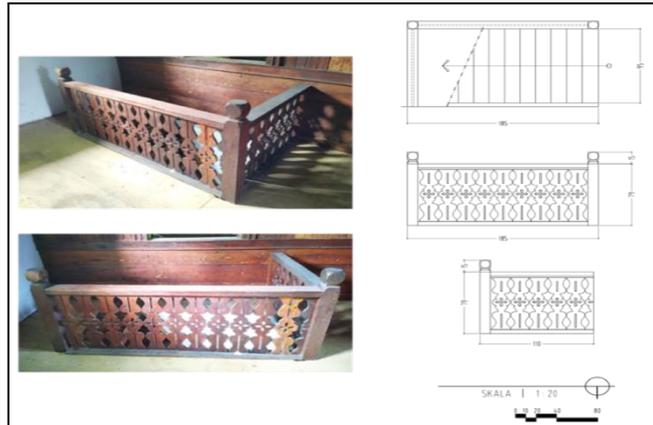
Figure 6. wooden stair railing

Stairs Rehabilitation Method There are two types of stairs in Rasuna Said's house, namely stairs made of concrete and stairs made of wood. Stairs made of concrete are stairs from the main house building which is in the middle to the kitchen at the back. The condition of the concrete stairs is still good, it's just that maintenance needs to be done because the paint on this staircase has been peeling off a lot. This concrete staircase maintenance method is first carried out by stripping all existing layers of paint by brushing with an iron brush and assisted by sanding so that the paint layer is completely clean. Cleaning with sandpaper so as not to release a lot of dust can be done by watering or wetting it when sanding. After all the layers of paint have been removed or are clean, the next step is painting. If there are pores or small holes on the stairs wall, the pores are closed first with dompol and followed by plastering the entire surface of the staircase wall. Finally, a painting job is done with good quality wall paint as desired.

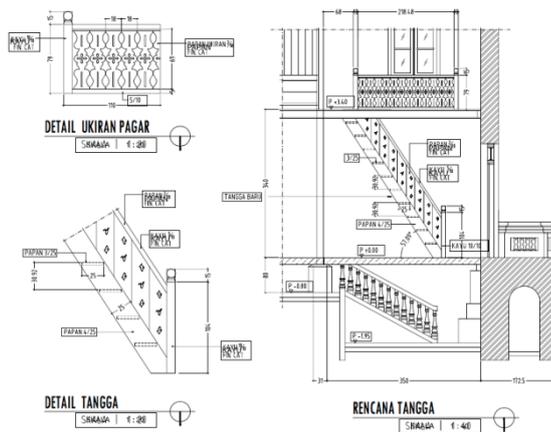
Figure 7. The wooden staircase of Rasuna Said's house.

The rear middle staircase currently does not exist because it was opened during renovations in 2013 by PT. Garuda Indonesia through its CSR funds. The rear ladder will be reassembled according to the original position of the ladder, and will use the same wood material with good quality and strength. The wood chosen is wood that is completely dry so that there is no shrinkage of the wood when the ladder is installed. The last job as finishing the stairs was done by painting with the same paint color and paint quality as the existing wooden stairs paint.
