Analysis of Water Loss in the District of Meter Area (DMA) Bumi Kepongongan Indah Regency, Cirebon for Civilization

Abstract

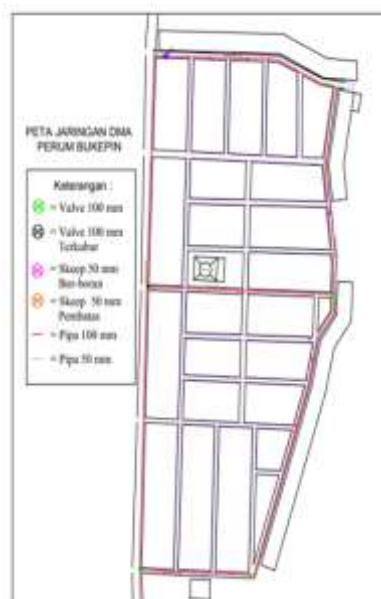
Figure 3. Map of Bukepin Regency DMA Network

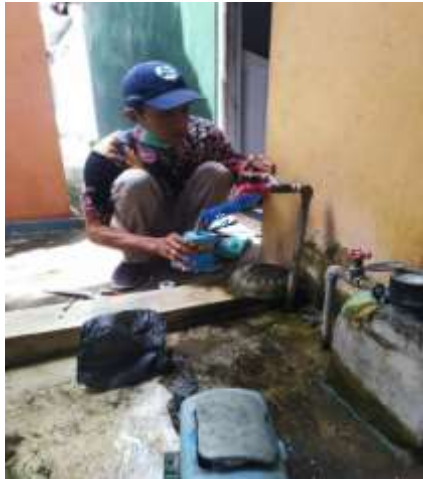
Figure 4. Installation of pressure logger data

Installation of a Pressure Data Logger to measure water pressure in the distribution network for 24 hours to find out the pressure pattern that exists in the distribution network. In addition, from the pressure measurements made, it can also be seen the AMM (Minimum Night Flow) time in the distribution network. In this step, the pressure measurement is carried out for ± 24 hours spreading to several points, either upstream, middle, downstream or random distribution. The pressure measurement is read every 15 minutes by the data logger.

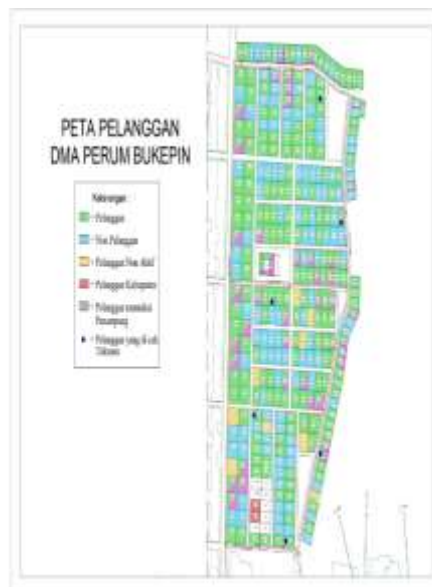
Figure 5. Map of Bukepin Regency DMA Network
