Performance Analysis of Pedestrian Roads Around the Andi Pangeran Pettarani Road Corridor, Makassar City

Street Andi Pangeran Pettarani is one of the protocol roads in Makassar City and is located in a strategic area. Residential buildings along the Andi Pangeran Pettarani axis road have now turned into commercial buildings such as culinary or restaurant buildings, shops, hotels, offices, non-formal formal educational institutions, and even health services such as clinics and hospitals. The owner of the building builds in the border area of the building for these commercial activities. This then causes the unavailability of parking space for vehicles. Visitors who have vehicles will use sidewalks, road shoulders and even part of the road as a parking lot so that pedestrian paths in the form of sidewalks become unsafe and comfortable. The study was conducted on the sidewalk along the corridor of Andi Pangeran Pettarani, Panakkukang District, Makassar City. The 4 kilometer long axis road is divided into 6 segments for easy observation. This study aims to evaluate the utilization and availability of sidewalk support facilities and the level of pedestrian satisfaction with the sidewal

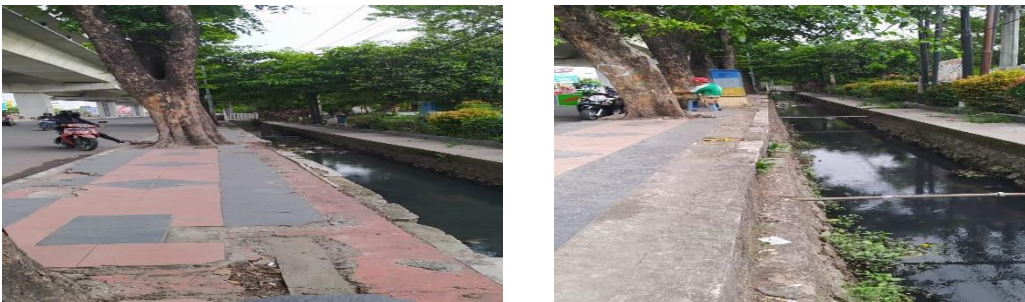
The reality in the field of physical development for pedestrian paths along the Andi Pangeran Pettarani road corridor is still inadequate, this is proven by the many points of pedestrian paths that have been damaged, etc. cause problems on the pedestrian path itself. The number of problems certainly disturbs pedestrian activities from feeling safe, comfortable, and humane.

Figure 1. *The condition of the pedestrian path on Jalan Andi Pangeran Pettarani*

In connection with the above explanation, it is deemed necessary to conduct an assessment of the utilization and availability of supporting facilities for pedestrian paths along the Andi Pangeran Pettarani road corridor. The assessment was carried out through field observations and an assessment of the level of pedestrian satisfaction with the sidewalks, both in quality and quantity in accordance with certain standards and criteria. The results obtained will be used in compiling recommendations for pedestrian-friendly sidewalk planning directions that refer to the level of user satisfaction, so that proposals and recommendations can be drawn up in terms of increasing comfort, both physical comfort and the five senses of pedestrian path users. These improvements are expected to increase user comfort so that it can be applied and utilized on other pedestrian paths and restores the actual function of the sidewalk.

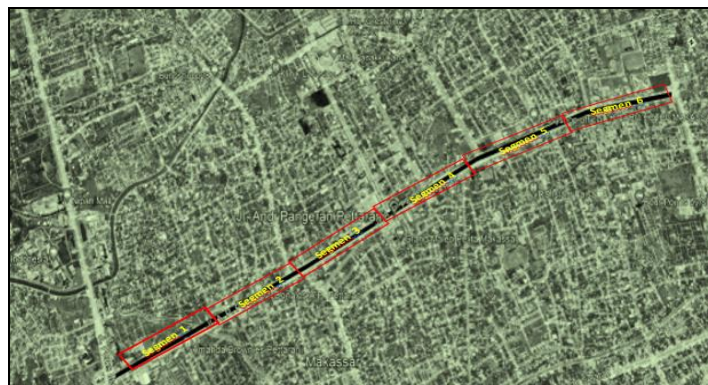
The length of the corridor of Jalan Andi Pangeran Pettarani which is the object of research is 4.08 km starting from the red light on Jalan Urip Sumoharjo which is the entrance to the Ujung Pandang toll road to the physical boundary of Sultan Alauddin Road or the location is right under the Pettarani Flyover Toll Road. Meanwhile, the width of Andi Pangeran Pettarani's axis road takes a limit based on the width of the Road's Space or Rumija. Identification is done by dividing the axis road into 6 segments based on the intersection boundary with the consideration that a typical pedestrian path between intersections physically has a relatively similar shape so that it is easier to make observations. The sidewalk facilities and infrastructure are analyzed by categorizing them into several aspects based on the function of each of these supporting facilities, including continuity, safety and security, and comfort and accessibility.

Figure 2. Segment Division Map
