# Study The Severe Effects of Iron Compounds Presenting in Sandstone on the Deterioration of Wall Paintings of Archaeological Tombs in Bahariya Oasis - Egypt

**Abstract :** The Wall paintings in Bahariya oasis expose to various deterioration factors, especially the resulted deterioration from the geological nature of sandstones' supports; sandstone of Bahariya formation is considered the weakest sandstone type in Egypt because of its geological formation which contains a very big percentage of iron oxides. Sandstone samples were taken, analyzed and examined by x-ray diffraction and scanning electron microscope, the iron oxides are the cement material in sandstone which affect negatively on the wall paintings in the selected tombs (Badi –Ishtar and Bannantiu tombs), they caused a lot of deterioration phenomena to the wall painting layers like: layers loss, black spots, cracking through all the layers and sandstone support weakness that threatens the remaining wall paintings and the safety of the tombs. Iron oxides percentage in Badi – Ishtar tomb is more than Bannantiu tomb and this is reflected on the wall paintings case in Badi – Eshtar. This research sheds the light on this phen

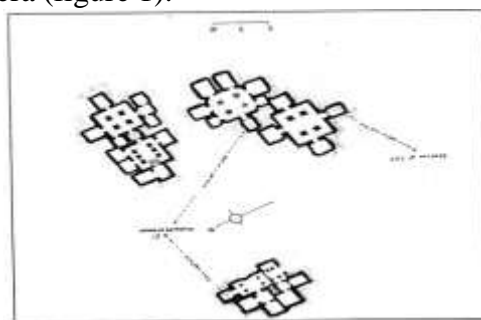
The remains of the views in this tomb expressed religious subjects like: festivals in the dead's book. The Entrance of the tomb is in the North and the visitor can reach for it by a well. The closet above the tomb was completely disappeared, the tomb consists of a hall with four columns, the tomb's ceiling is vaulted and there are also three small rooms. The original coffin is between the columns and beside this coffin, there are two stone coffins in the small hall returned to the Roman's era (figure 1).

**Figure 1.** The plan of Badi- Ishtar tomb

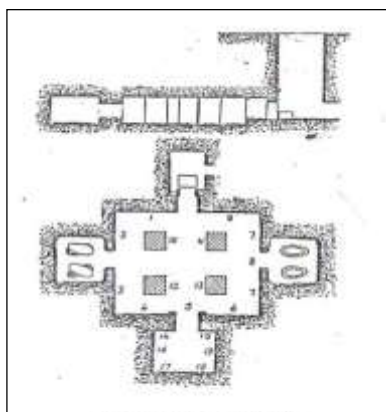
The closet of the tomb was completely disappeared, the visitor can reach to the burial room by a well with 6 meters depth, in the end of the well, there are two entrances, the first opens in South and leads to incomplete tomb empty from ornaments, the historians believed that this tomb was for his wife's burial-fig (2), the views of Bannantiu tomb expressed religious subjects also like: the moon and the sun's journey, the most important view in the tomb is Bannantiu stood opposite the god in the court of heart's weight. The tomb was discovered by Ahmed Fakhry in 22 April 1983, he took some photos for all the views in the tomb .After a year, he opened it again and found some black spots on the views and some scripts which were written with black ink on yellow backgrounds started to be dull, this phenomenon because of the existence of iron oxides in the sandstone support.

Figure 2. The plan of Bannantiu tomb

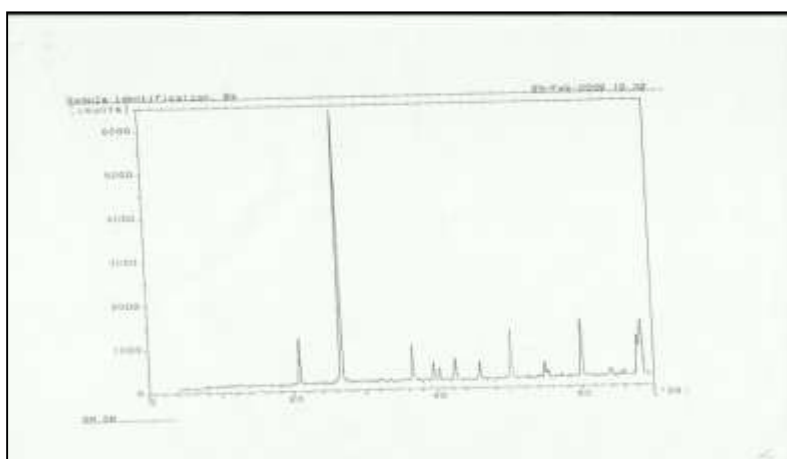
**Figure 3.** XRD pattern of the sandstone's sample from Badi-Ishtar tomb

Tomb Name	XRD Results	SEM examination
Badi-Ishtar tomb	1- The Major compound is Quartz " $\text{SiO}_2$ " approximately 69.35% 2- The Second compound is Wuestite" iron oxide" $\text{FeO}$ " approximately 14.1% 3- The Third compound is Goethite ( $\alpha\text{-Fe O (OH)}$ ) approximately 12.14%	Scanning Electron Microscope (SEM) examination presents the existence of clay minerals beside iron oxides which means the severe deterioration of wall paintings in high humid conditions. The clay

<p>4 The Fourth compound is Feroxyhite "iron oxides and hydroxides" approximately 4.4%.</p> <p>The total iron compounds are approximately <b>30.64%</b> of the total compounds percentage, which affect badly on the sand stone support because of their solubility in water-fig (3)</p>	<p>minerals will absorb water and swell, when water evaporates in high air temperature degrees, the clay minerals will shrink. The cycles of swelling and shrinkage will cause the severe deterioration to the wall painting layers beside the iron oxides dissolution – fig (4).</p>
<b>Bannantiu tomb</b>	<p>1- The major compound is Quartz "SiO<sub>2</sub>" "silicone di – oxide" approximately 77.58%.</p> <p>2- Wuestite "Ferrous oxide "Fe O" Approximately 9.54%.</p> <p>3- Goethite "α-Fe O (OH)" "Alpha iron oxide and hydroxide" approximately 7.8%.</p> <p>4-Feroxyhite "FeO OH" iron oxide and hydroxide" approximately 4.73%.</p> <p>5- Calcite "CaCO<sub>3</sub>" calcium carbonates" as a trace approximately 0.38%.</p> <p>The total iron compounds in the sample are approximately <b>22.3%</b> from the percentage of the total compounds- fig (5).</p>	<p>It was found from the scanning electron microscope examination that the sample contained clay minerals in its content, which will affect badly with iron oxide dissolution on the safety of the Bannantiu's tomb – fig (6).</p>

By the comparison between the iron compounds in the two samples, it was noticed that iron compounds ' percentage in the sample from Bannantiu tomb was approximately **22.3 %**, while the percentage in the sample from Badi-Ishtarwas approximately **30.64%**.

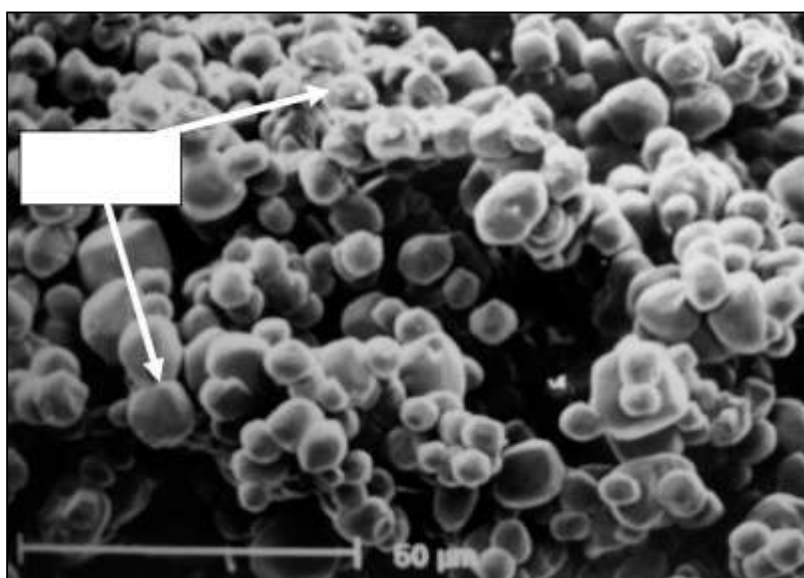
**Figure 4.** The SEM examination of the previous sample

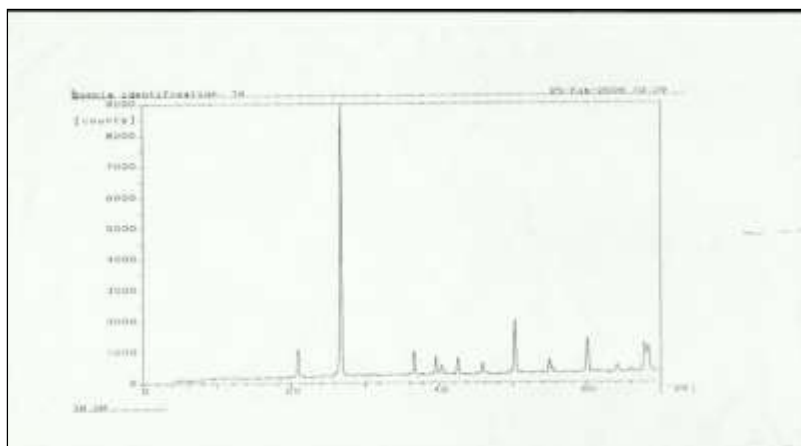
**Figure 5.** XRD pattern of the sandstone sample from Bannantiu's tomb

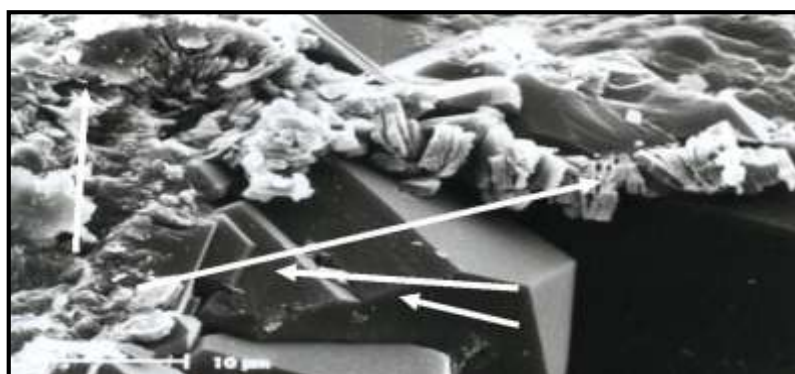
**Figure 6** The SEM examination of the sandstone's sample from Bannantiu tomb (Arrows refer to the iron compounds)

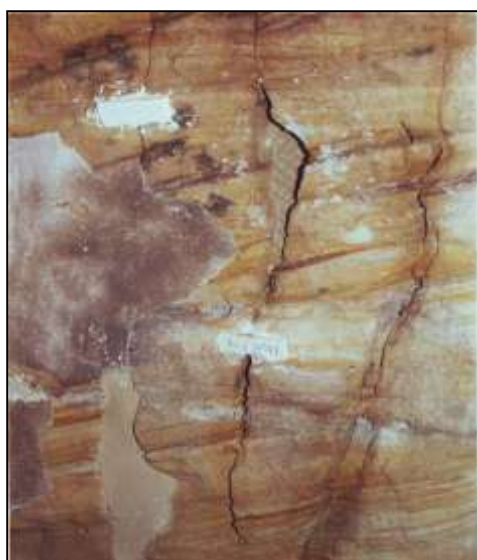
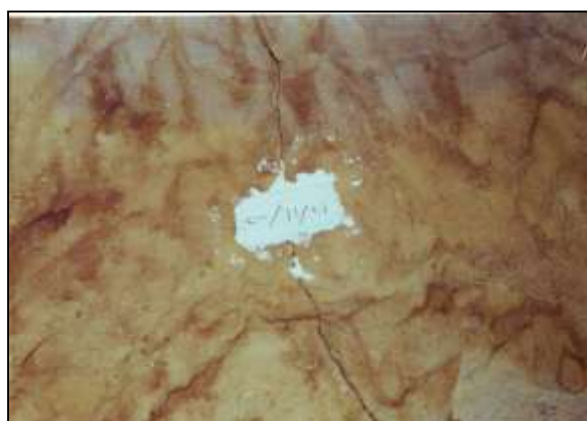
- Cracks in walls and ceiling of the tomb because of the sand stone's weakness, iron compounds dissolve in high humidity and the sandstone becomes very weak because of cement material's loss "sand stone bleeding" (figure 7-8).
- Partial separation between the wall painting' layers and the sandstone support "drumming phenomenon".
- Losing of the wall paintings' layers because of bleeding of the support (figure 9).
- Black spots deform the views of the wall painting because of the dissolution of iron oxides in high humidity content which went out on the wall paintings and deform them (figure 10).

**Figure 7-8.** cracks in one of the tomb's wall because of sandstone weakness

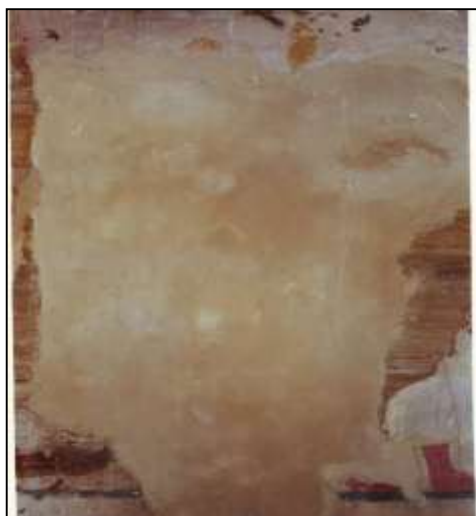
**Figure 9.** A Completely loss of the wall paintings' Layers which were completed with a Mortar consisted of sand and lime 4:1 with Namix"adhesive material"

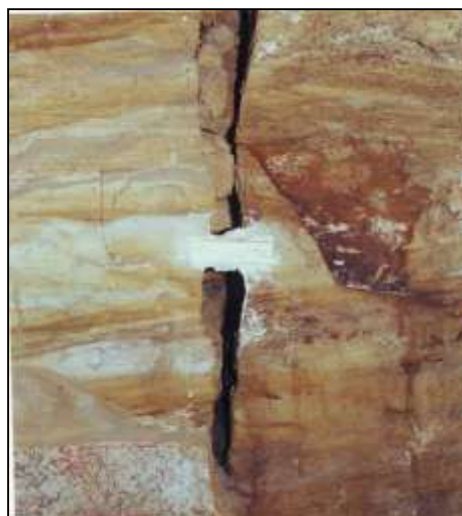
**Figure 10.** The Deformation of the wall paintings with black iron spots

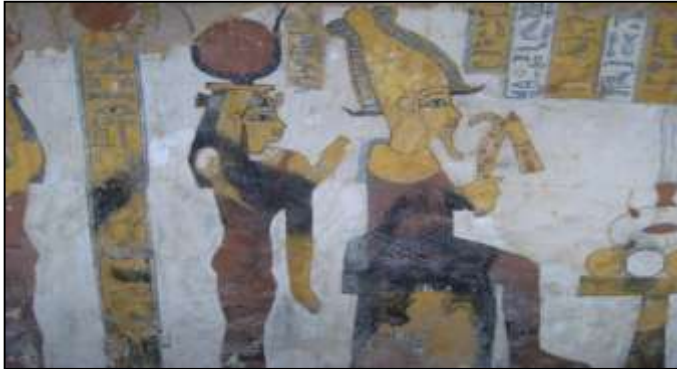
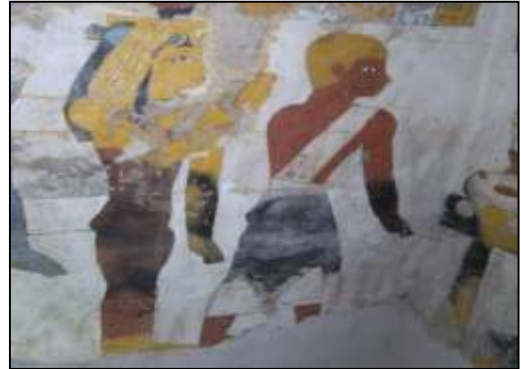
- a. Black spots on wall painting layers especially the colorful layer because of the migration of dissolved iron compounds in high humidity content on one hand but on the other hand, in low humidity content the water which united with the iron compounds evaporates causing the black spots (figure 11-12)

- b. It was noticed that the black spots increased in the area of yellow and red pigments because they consisted of iron oxides in the nature, beside the dissolution of iron

oxides in the support in the presence of high relative humidity that caused the concentration of black spots on these areas .

**Figure 11.** Black spots on the colorful painting layer

**Figure 12.** Black spots' migration through the colorful layer

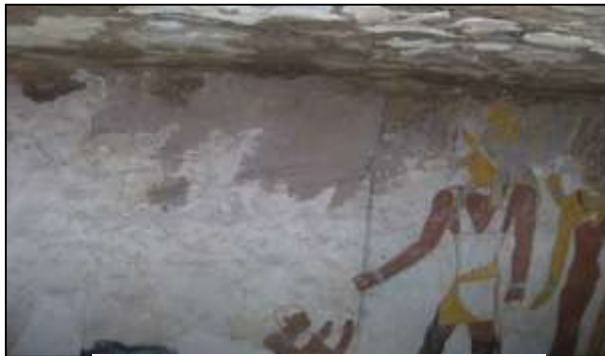
- b. Losing of the wall paintings layers because of sandstone bleeding.
- c. Falling of plaster layers because of their weakness figure 13.
- d. Macro and micro cracks in the plaster layers figure 14.

**Figure 13.** Falling of plaster layers because of their weakness

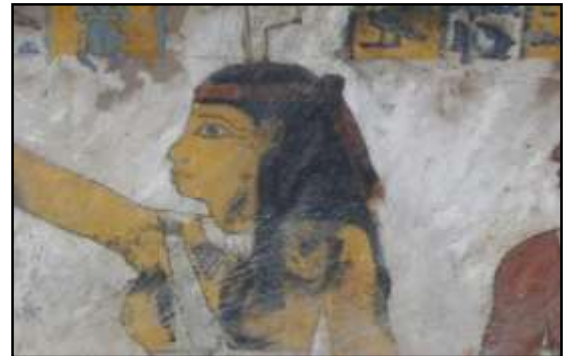
**Figure 14.** Cracks in the wall painting plaster layers

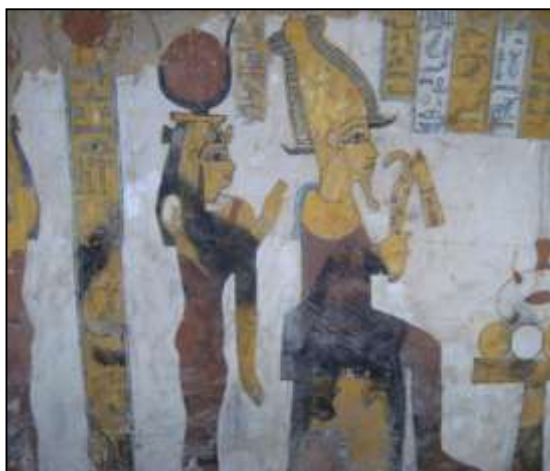
- e. Some pigments like yellow becomes dull- figure 15-16.
- f. Nabil (2000) mentioned that the pigments in Badi- Ishtarand Bannantiu wall paintings were:

**Figure 15.** The yellow pigment becomes dull

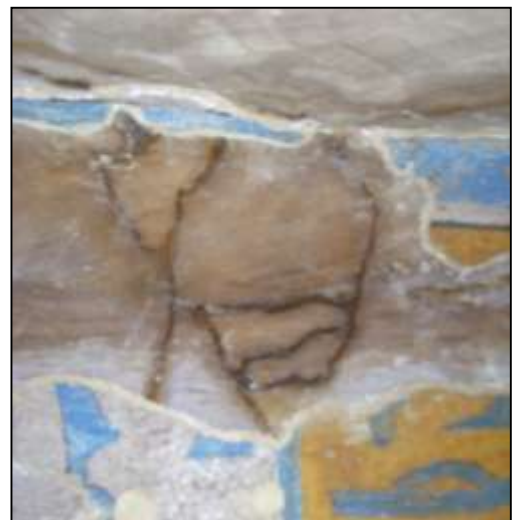
**Figure 16.** Iron veins in the sand stone support under the wall painting layers
